MVT Resistance: A Case Study

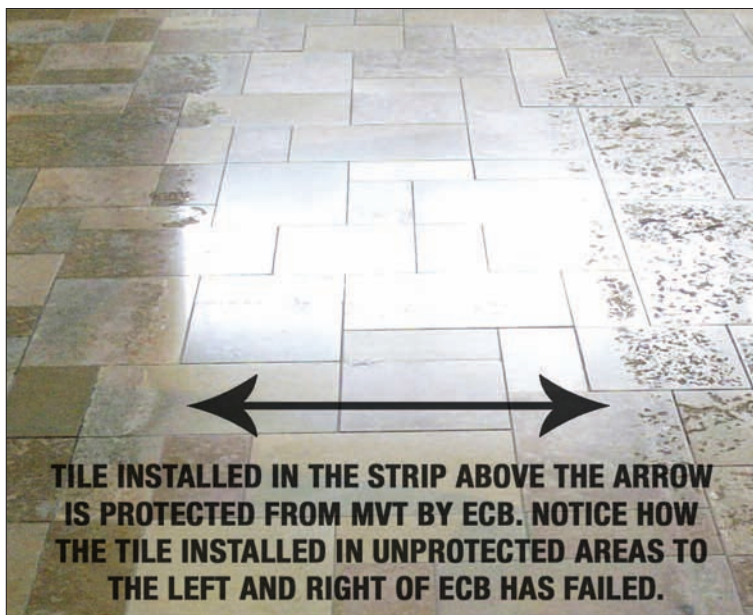
Note in the attached photo how this customer chose to use ECB Elastomeric Crack Bridging Membrane as a 36" wide strip application only. You can clearly see there is extreme deterioration everywhere to the tile except where the membrane is applied. Full Floor Coverage of ECB, Strataflex, SAM³ or Super SAM would have kept this new tile floor looking good throughout the life of the building. Without the system, the floor failed, a costly mistake. Our industry must address this issue and plan for Full Floor Coverage to avoid MVT issues. Use quality Membrane Systems and the industry wins.
